REPORT 66577/G

**TESTING OF
VALENTIA STONE**

VALENTIA STONE

Carrig Conservation International Ltd.
Unit 2, Atlantis Building
Cumberland Street South
Dublin
D02 V588

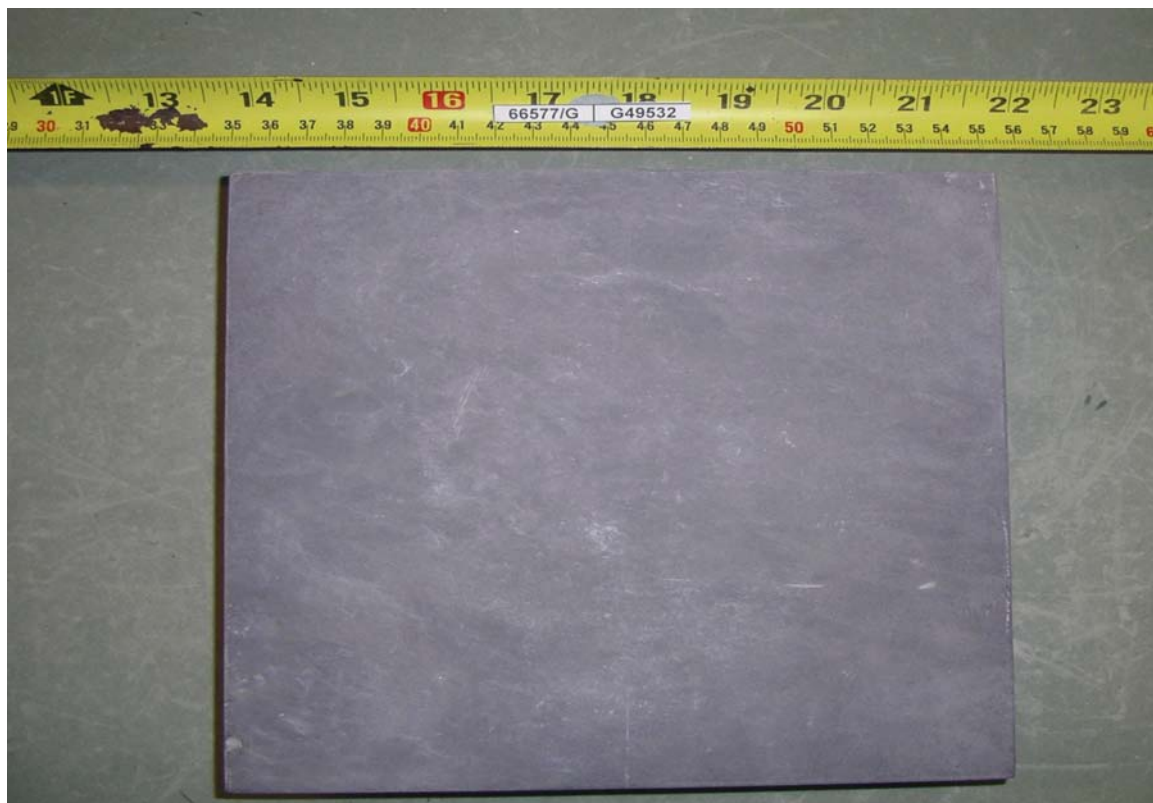
G49532: General view of a principal surface of Valentia sample.

Record photographs of the sample are presented in Table 1.

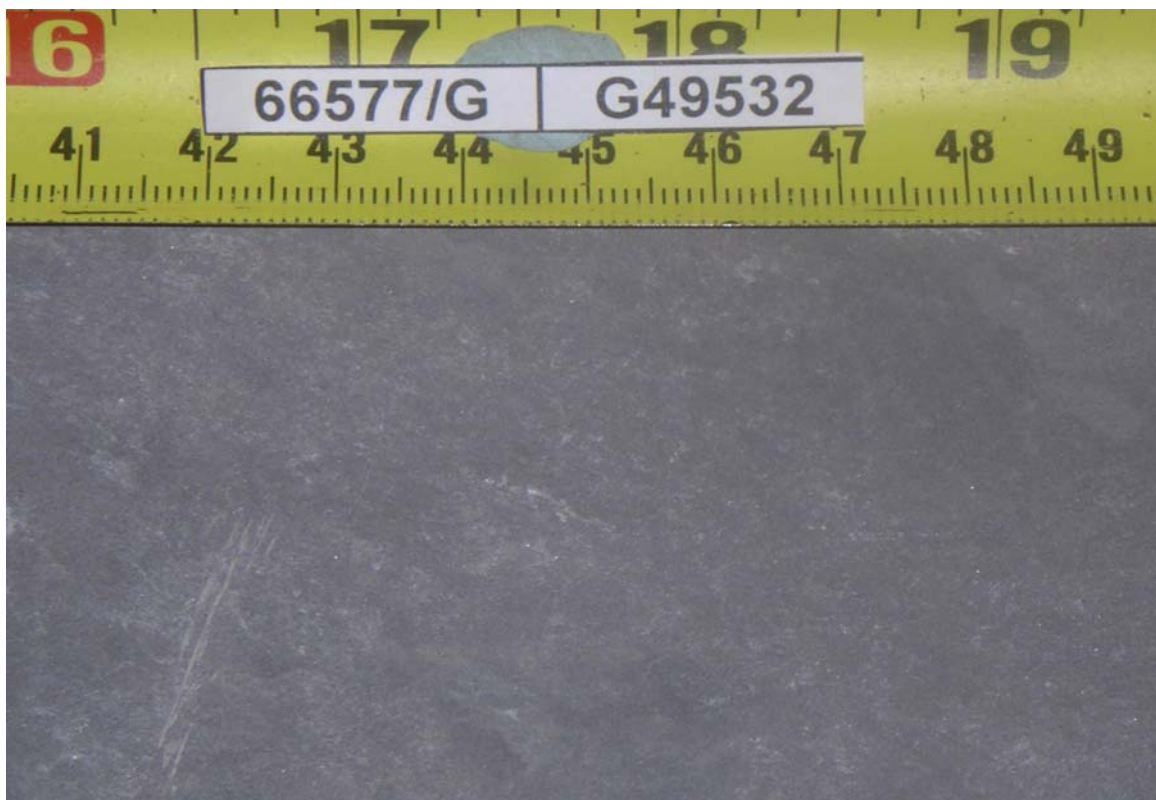
G49532: Close-up of a principal surface of Valentia sample.

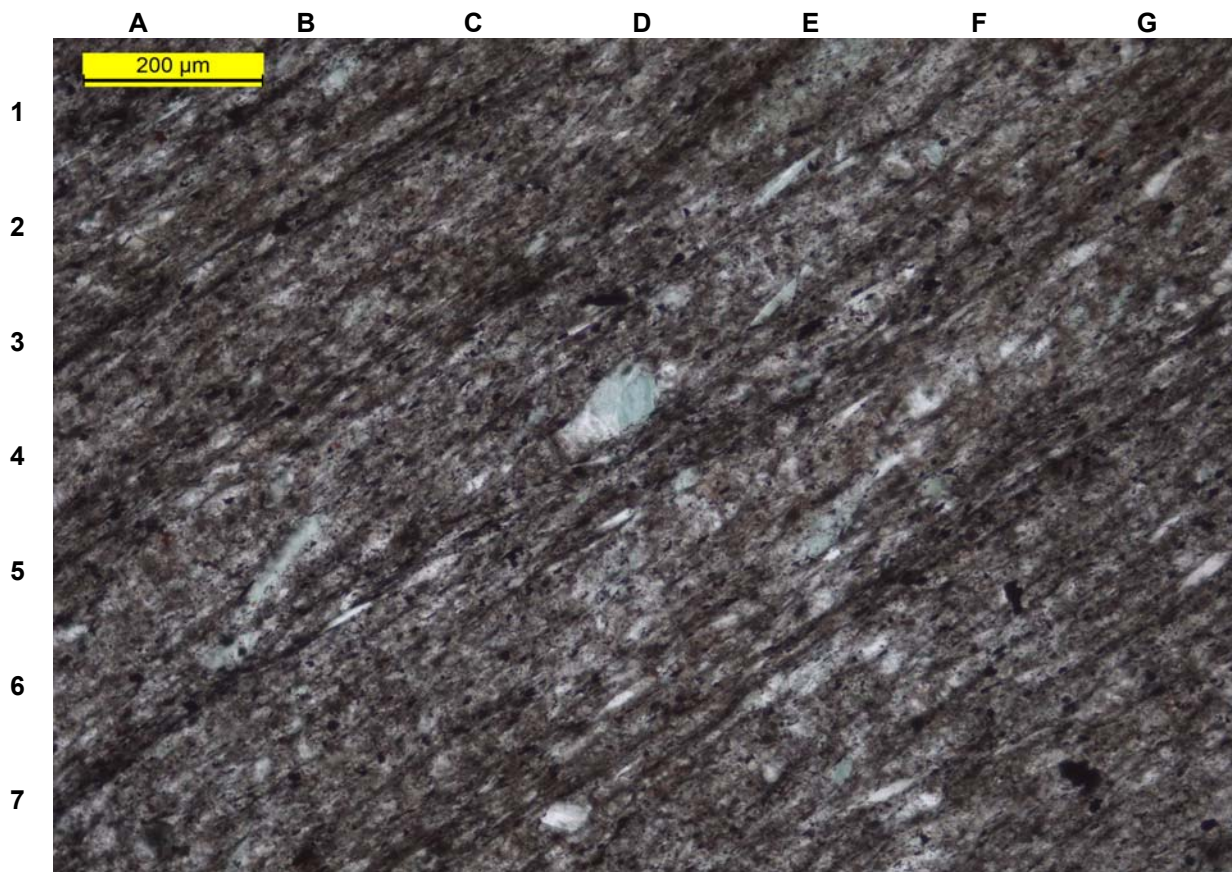
66577/G
Table/Sheet 1/3
Plate 1

Photomicrograph Details			
Sandberg Sample Ref:	G49532 (perpendicular to cleavage)	Client Ref/Site Mark:	Valentia
Microscope Light:	Plane polarised	Objective Magnification:	x10
Photomicrograph Description			
<p>General view of stone structure under plane polarised light. The stone is generally fine grained. The background consists of quartz, mica layers which are orientated south west to north east and are also intermixed with calcite and chlorite (green, C-D/3-4). The black fine material is iron oxide and possibly some pyrite.</p>

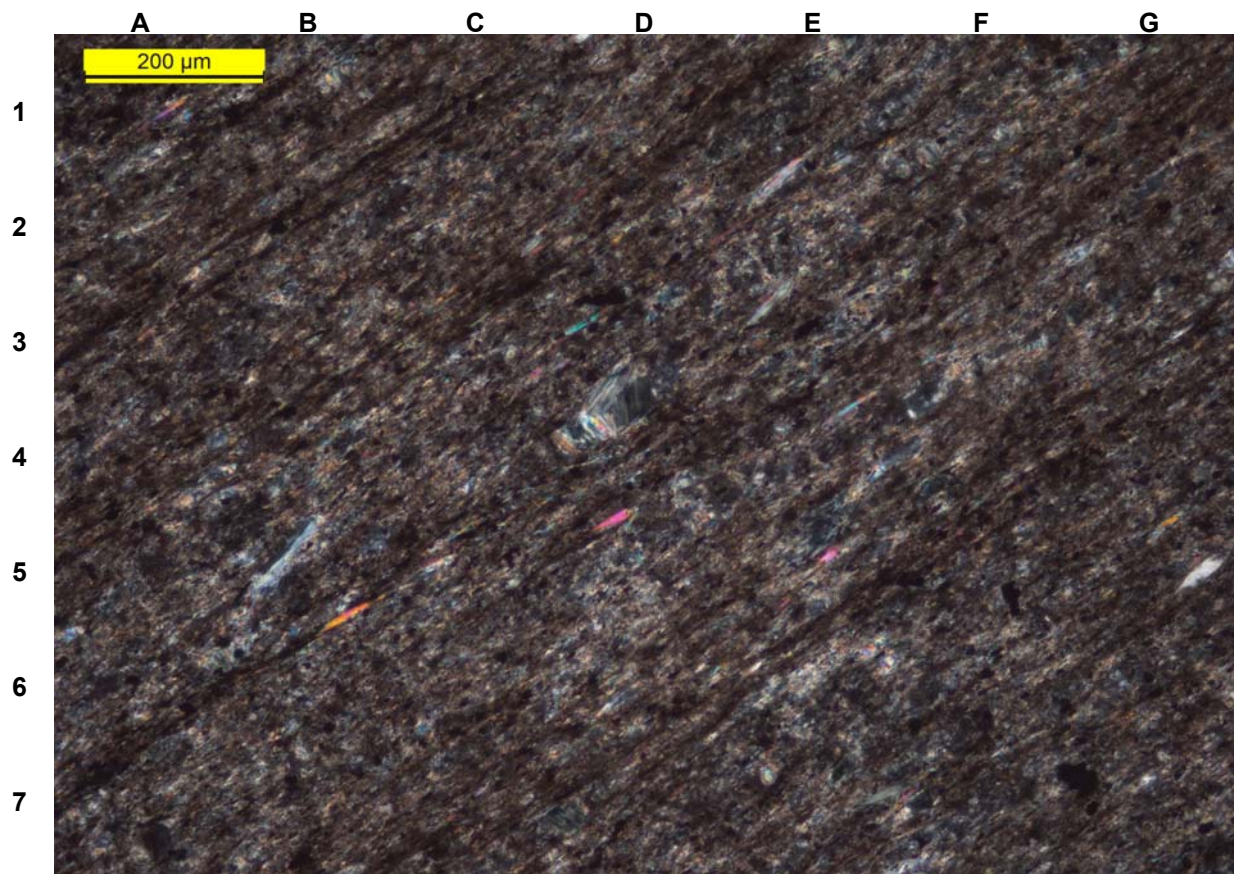
66577/G
Table/Sheet 1/4
Plate 2

Photomicrograph Details			
Sandberg Sample Ref:	G49532 (perpendicular to cleavage)	Client Ref/Site Mark:	Valentia
Microscope Light:	Cross polarised	Objective Magnification:	x10
Photomicrograph Description			
<p>General view of stone structure under cross polarised light. The stone is generally fine grained. The background consists of quartz, mica layers which are orientated south west to north east and are also intermixed with calcite and chlorite (green, C-D/3-4). The black fine material is iron oxide and possibly some pyrite.</p>

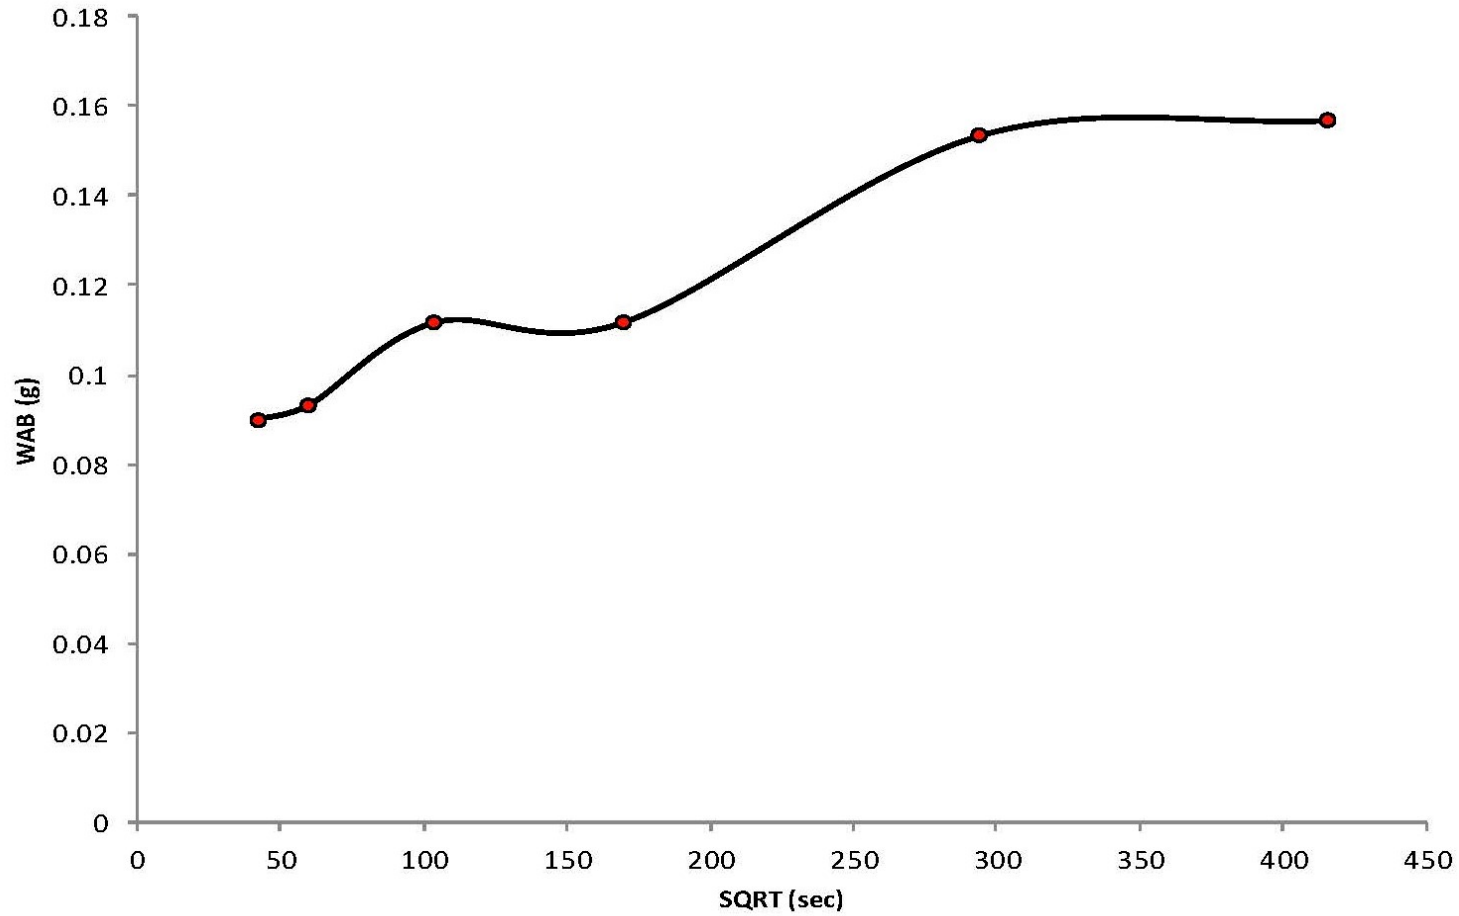
Table
4

G49534

Coefficient of water absorption by capillarity : $0.4 \text{ g/m}^2\text{s}^{0.5}$

DETERMINATION OF WATER ABSORPTION COEFFICIENT CAPILLARITY
BS EN 1925:1999

Sandberg Reference	Water absorption coefficient capillarity (g/m ² .sec ^{0.5})
G49534	0.4

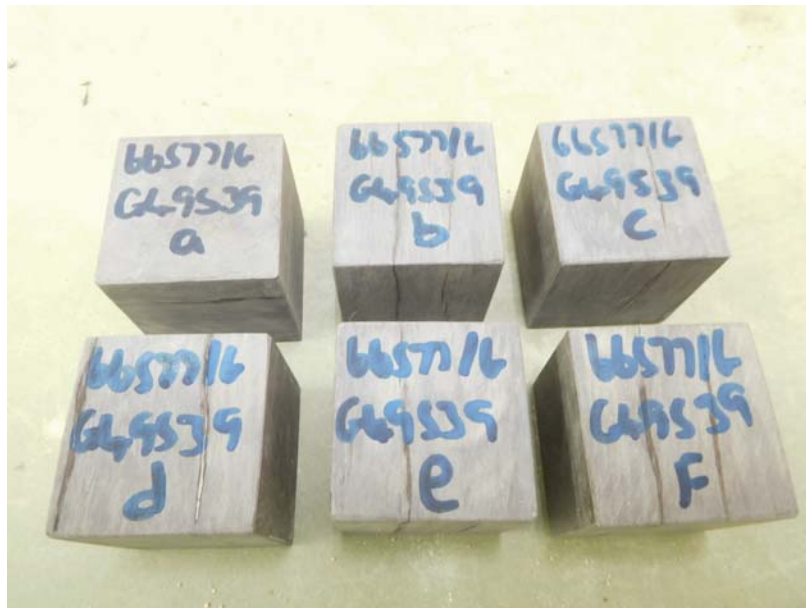
PHOTOGRAPH OF SPECIMENS ON COMPLETION OF TEST

Sandberg Ref.	Weight Loss (15 cycles) %	
	Range	Mean
G45939	0.00 - 0.01	0.00
