# VALENTIA SLATE, VALENTIA, CO KERRY, IRELAND

## Laboratory Report on Material Analysis

November 2020

CARRIG  
conservation international

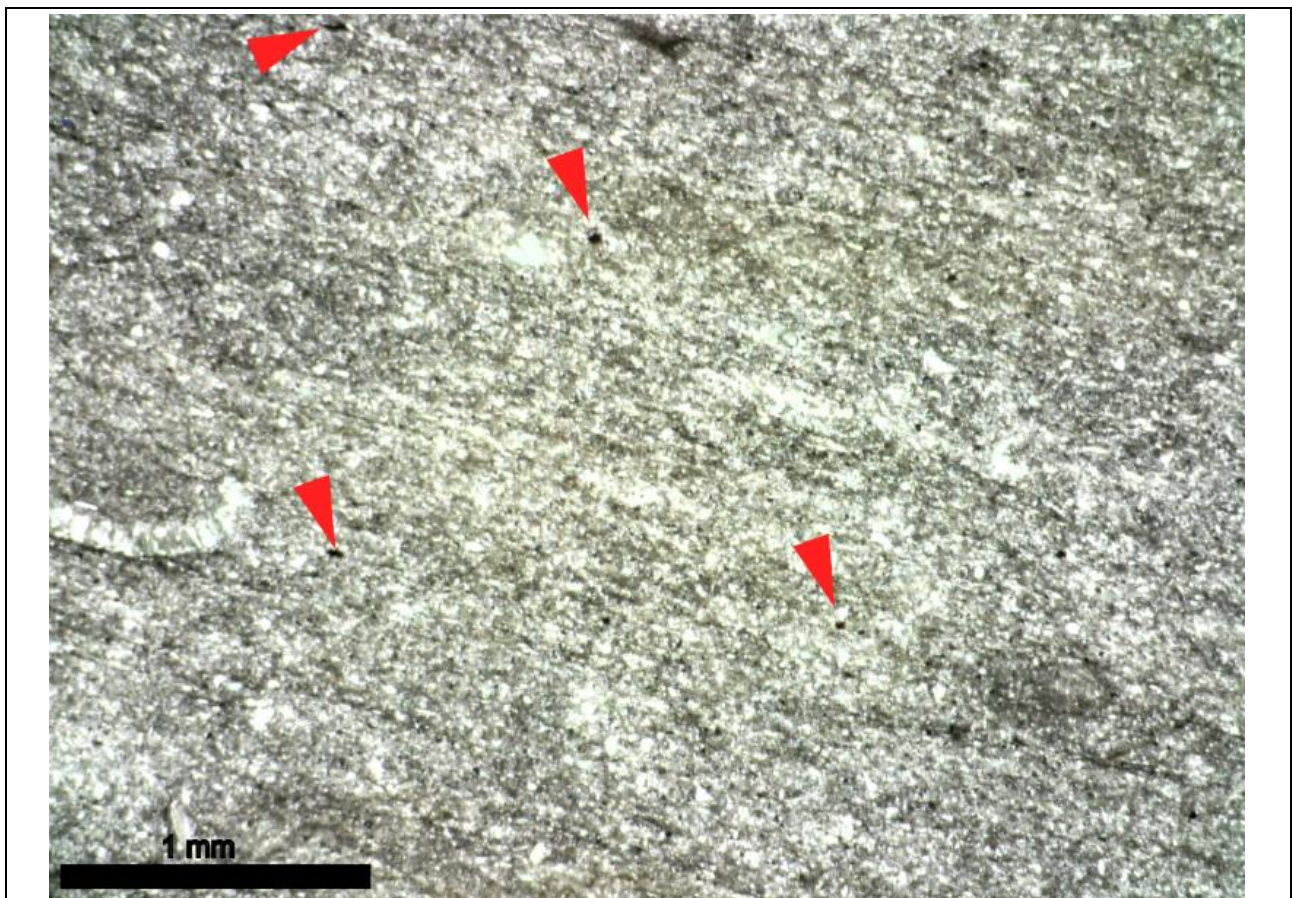
Fig. 1a. Photomicrograph of Sample 1 (Valentia Slate) in transmitted light. Examples of opaque grains arrowed.

Sample 1 Valentia Slate (Figure 1): The thin section shows silt and clay grade silicate minerals. The section was systematically scanned in transmitted light to identify any opaque grains that could have been pyrite (Figure 1a). The opaque grains were then observed in reflected light (Figure 1b). None of them exhibited the high reflectance and characteristic colour of pyrite.
